GEOTECHNICAL COMPLETION REPORT

SOLWAY SUBDIVISION

285 ARA-KOTINGA ROAD

DOCUMENT Geotechnical Completion Report for Residential
Lots 1 through 26 (inclusive)

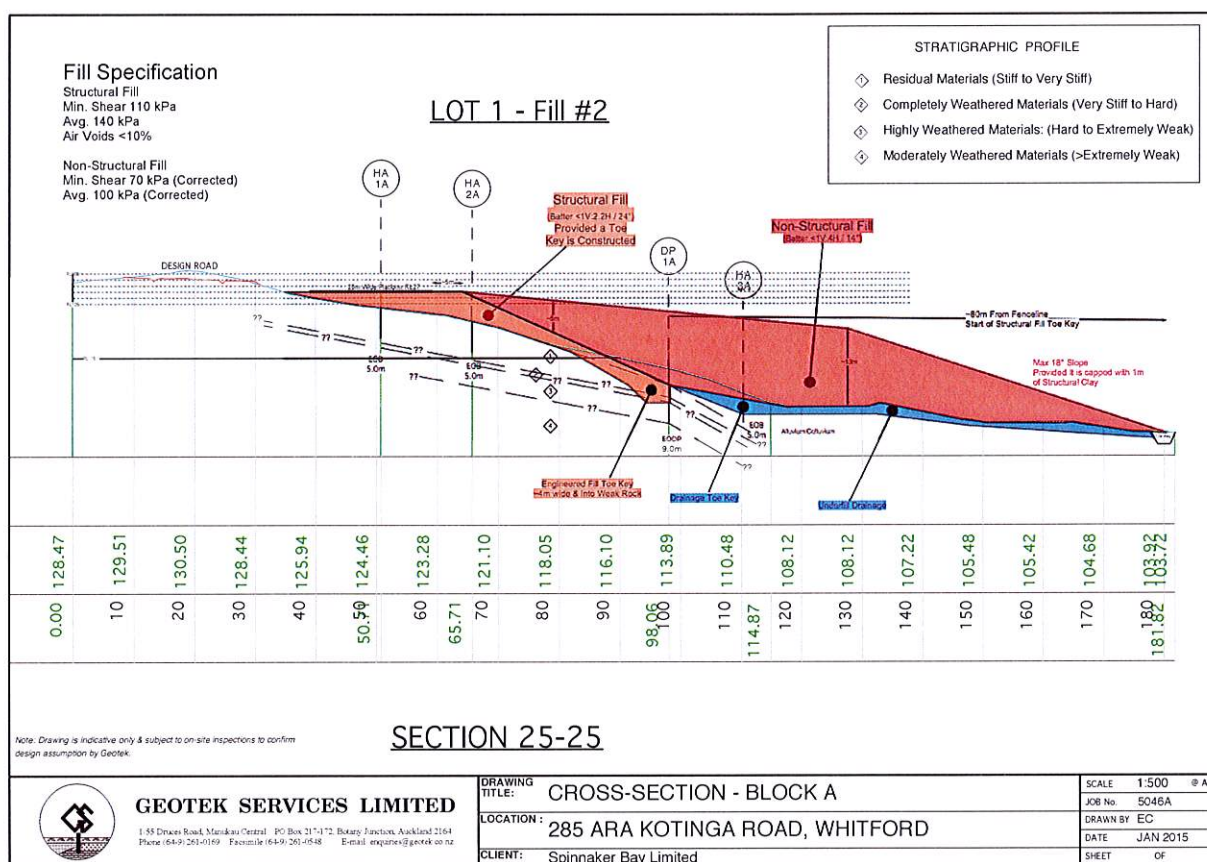
Figure 1 - Lot 1 Embankment Gully Fill Design & Earthworks Specification

Once the subsoil drainage was installed in the lower half of the gully, filling with clay fill commenced. The fill comprised excess spoil, which was cut down from the elevated ridgelines, as the road was being formed beyond CH900 for the main area of Stage 2. The material was wet, very silty and sensitive in nature and

compaction to the engineered specification was not achievable. We therefore revised the fill specification to allow for a lesser required undrained shear strength of no less than 70 kPa, with average strengths being around 100 kPa, which we refer to as "Non-Structural Fill". The embankment design was also revised to accommodate this large volume of lesser strength fill anticipated, but at the same time still requiring high strength good quality fill, referred to as "Structural Fill", to underlie and support the DBP. We therefore developed an embankment design that catered for both requirements, which is shown in figure 1 below. In addition, a 3 metre wide toe key was constructed, where the structural fill rises up from the gully invert, comprising a combination of drainage metal and rotten rock.
